New Acton  
South –  
Cladding  
Elevation Images

Source: Page 25 of The Warrington Fire Report - Combustible cladding risk assessment CRA1.1 New Acton South, Block 3, Section 24, City, ACT

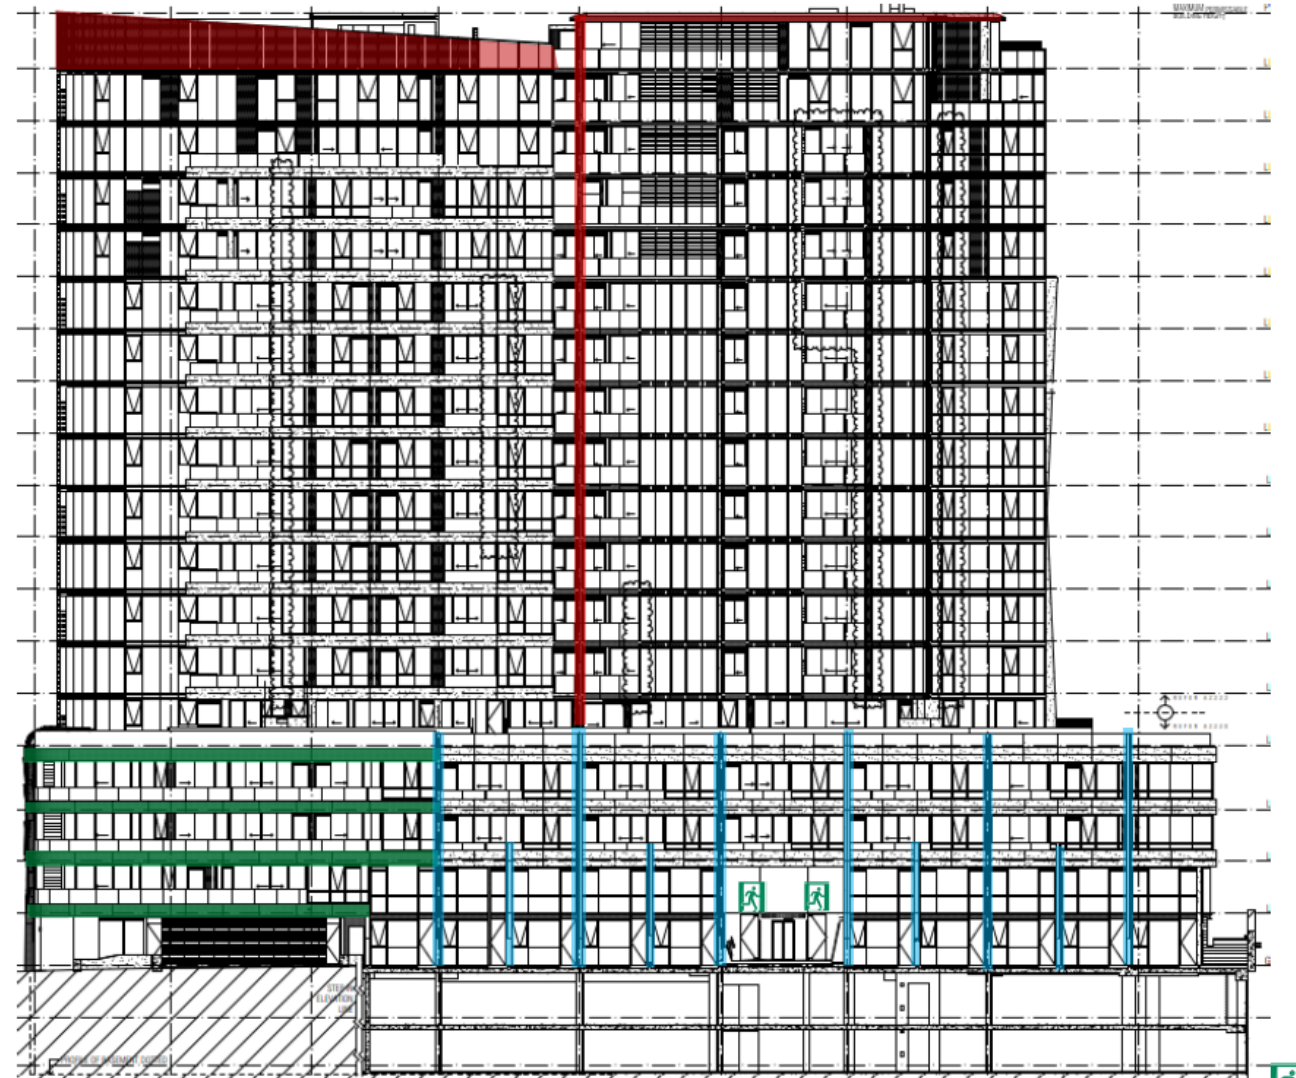
Figure 3 North elevation

Figure 3 / Cladding Element 7 / Vertical column to north elevation - **Non-combustible & will not be replaced**

- Cladding element 1- External spandrel panels to north, east and south elevation
- Cladding element 5- External timber fins to north elevation
- Cladding element 7- Vertical column to north elevation
- Cladding element 8- Roof parapet

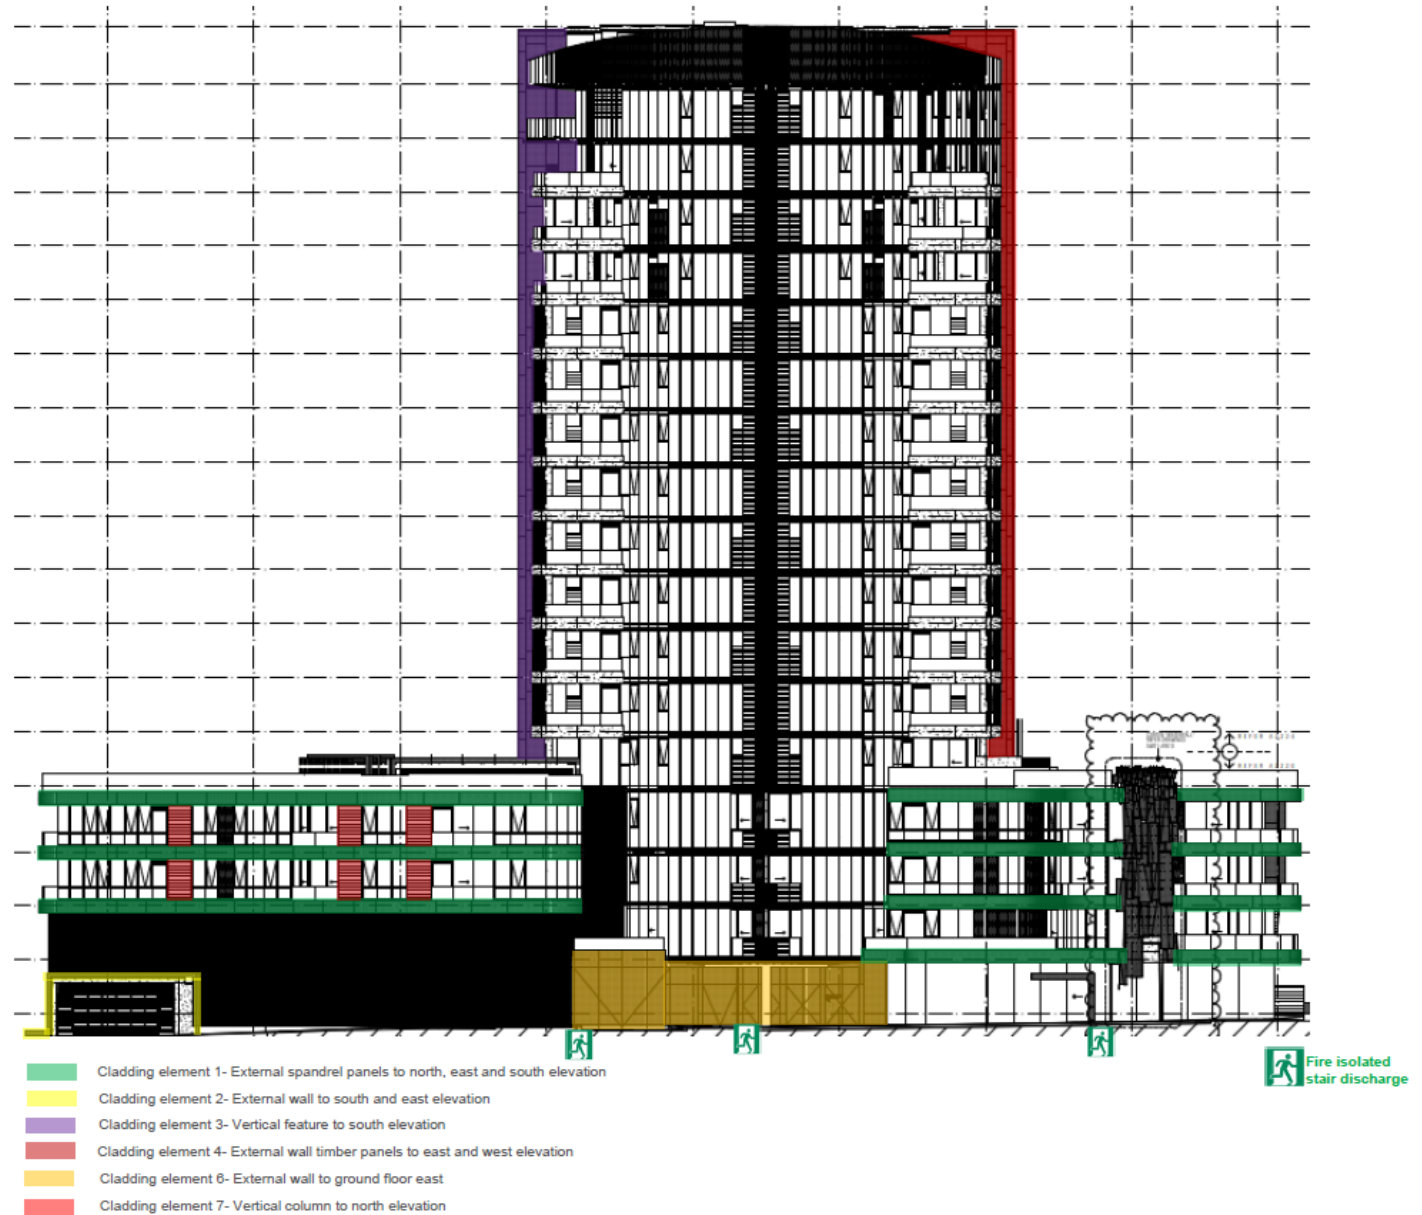
Figure 4 East elevation

Figure 4 / Cladding Element 3 / Vertical feature to south elevation - **Non-combustible & will not be replaced**

Figure 4 / Cladding Element 7 / Vertical column to north elevation - **Non-combustible & will not be replaced**

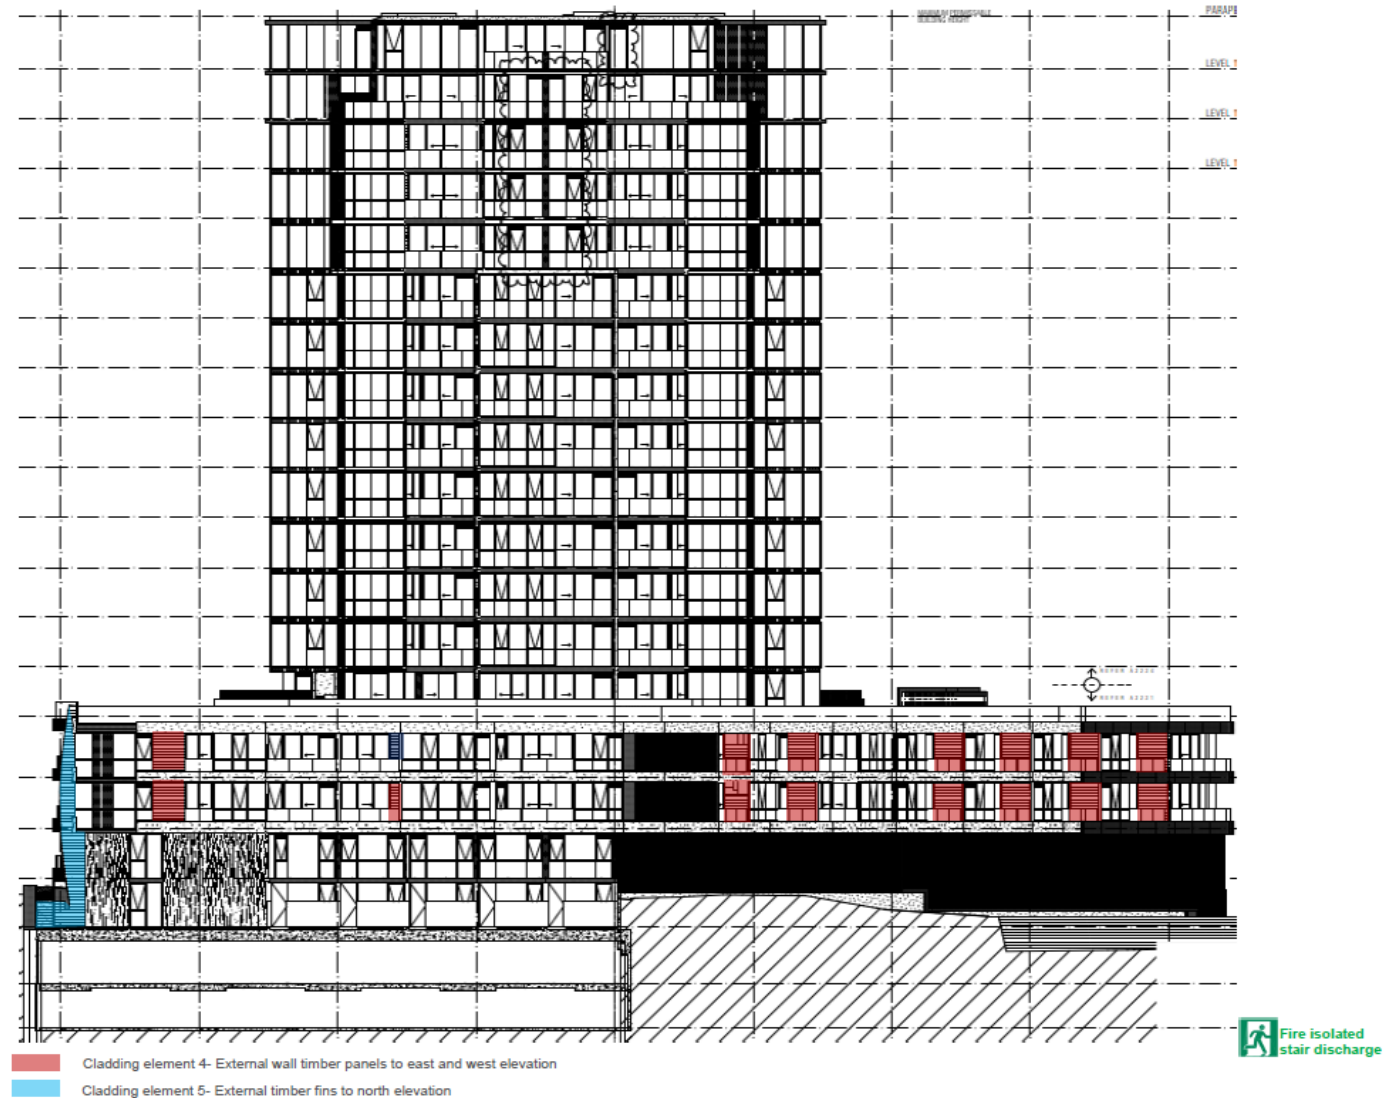
Figure 5 West elevation

Please note: The replacement of the cedar panelling present internal to balconies, will occur, however it is not shown on the elevation diagrams

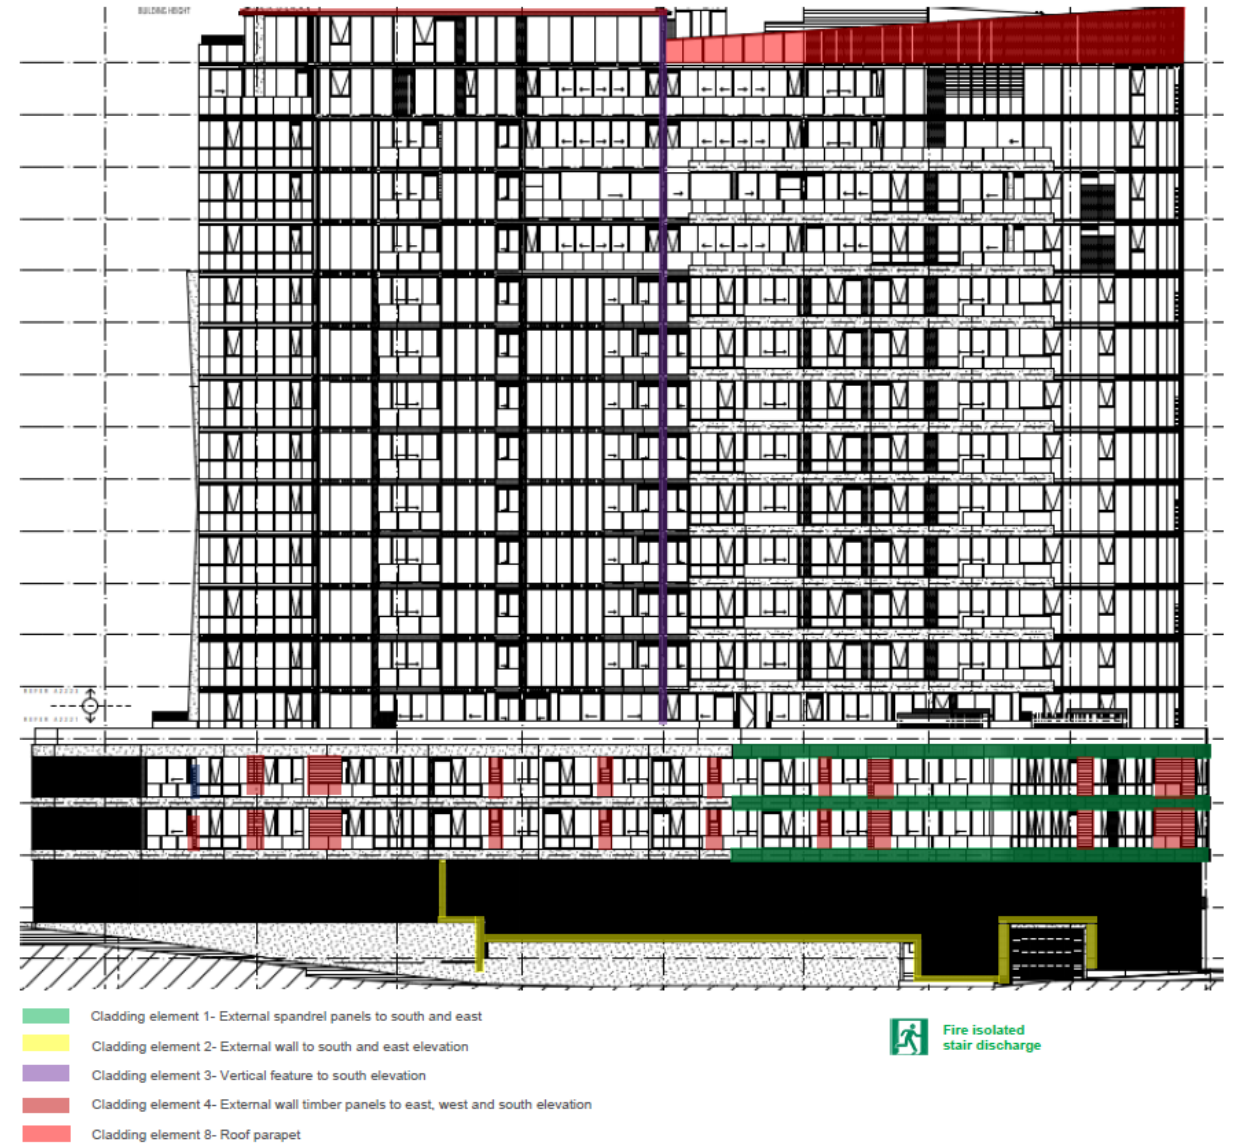
Figure 6 South elevation

Figure 6 / Cladding Element 3 / Vertical feature to south elevation - **Non-combustible & will not be replaced**
